STRUCTURAL *COLLAPSE* LITTLE FALLS

by Hugh Price-Hughes

On 16 October 2008 the City of Johannesburg Emergency Management Services received a call that a building had collapsed on the corner of Hendrik Potgieter and Van Staden roads in Little Falls, Johannesburg.

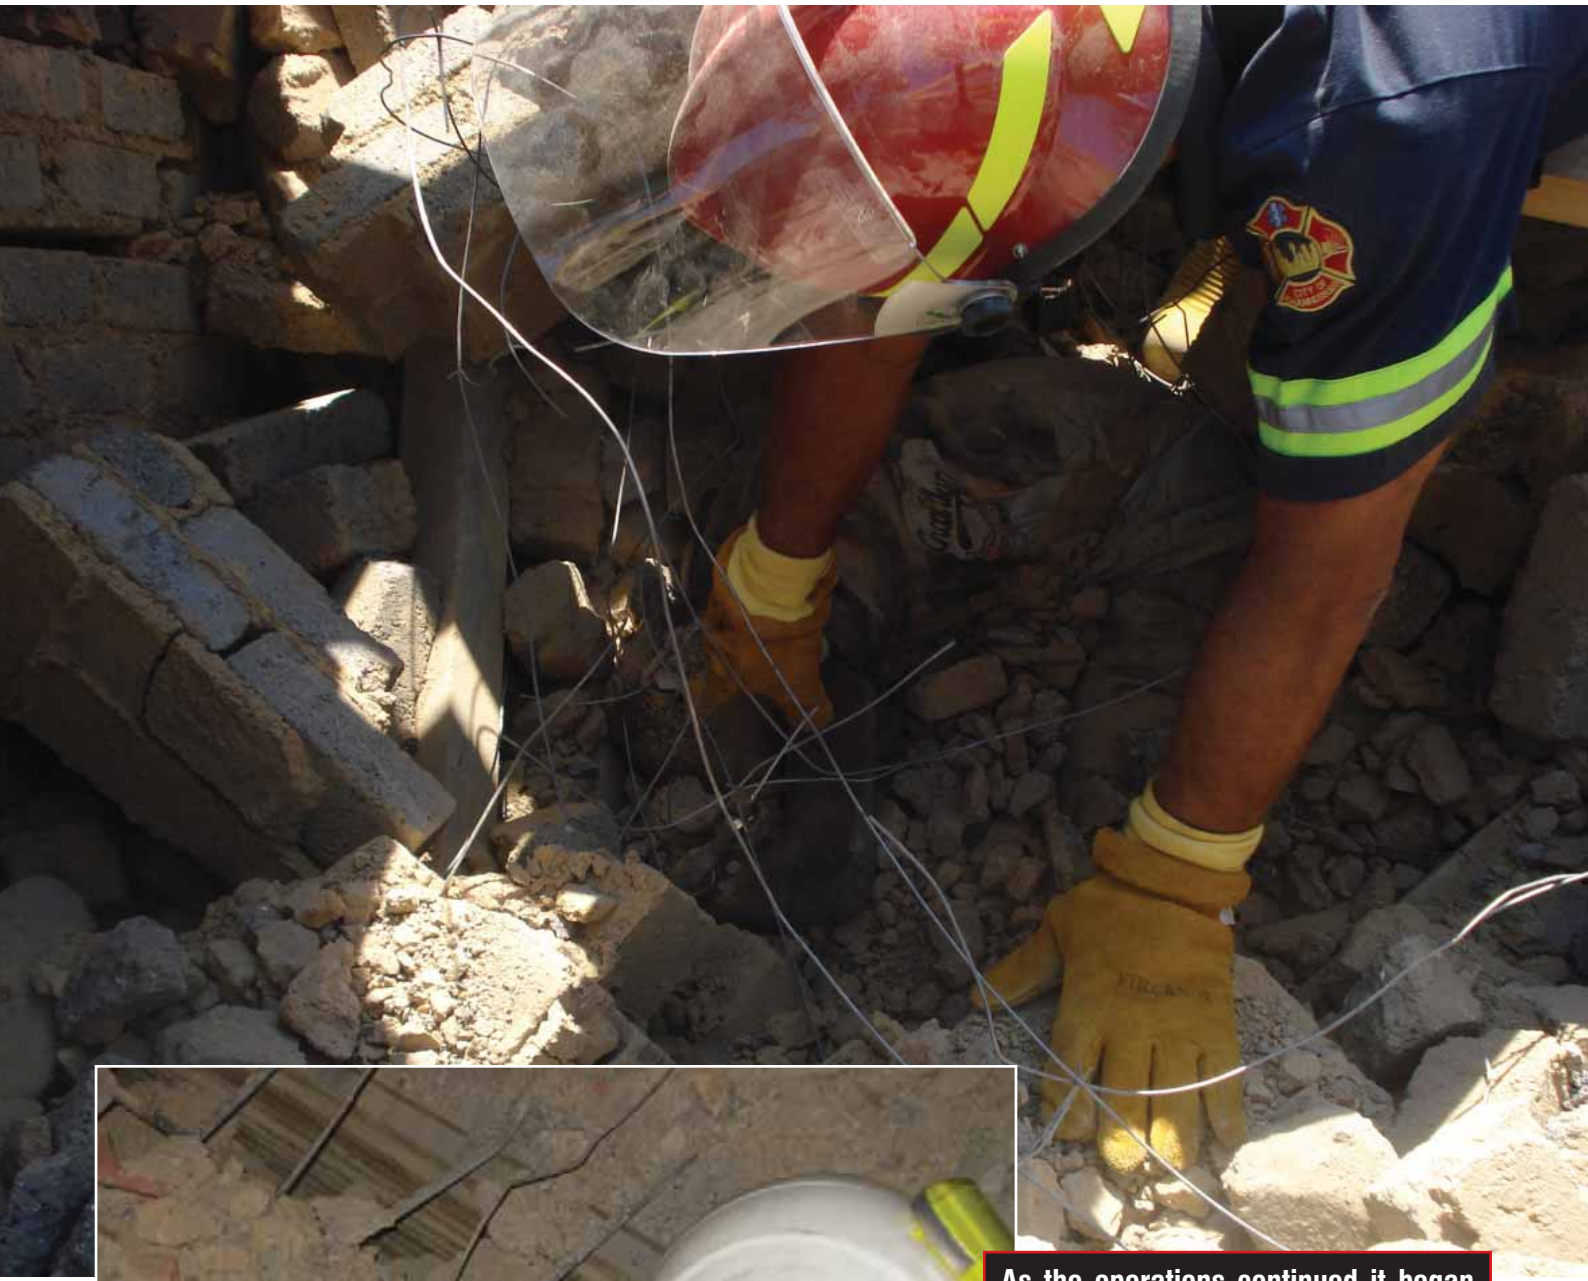
Mr Richmond completed a survey of the site and the building was condemned. It appeared that there were numerous contributing factors which caused the collapse. These include a lack of top steel (the reinforcing bars that join a pillar to the floor slab) and the concrete appeared to have insufficient cement in the mixture. As the weight of the roof tiles was added to the structure, the pillars punched through the floor slab causing the collapse.

It appeared that there were numerous contributing factors which caused the collapse
