STRUCTURAL *COLLAPSE* LITTLE FALLS

by Hugh Price-Hughes

On 16 October 2008 the City of Johannesburg Emergency Management Services received a call that a building had collapsed on the corner of Hendrik Potgieter and Van Staden roads in Little Falls, Johannesburg.

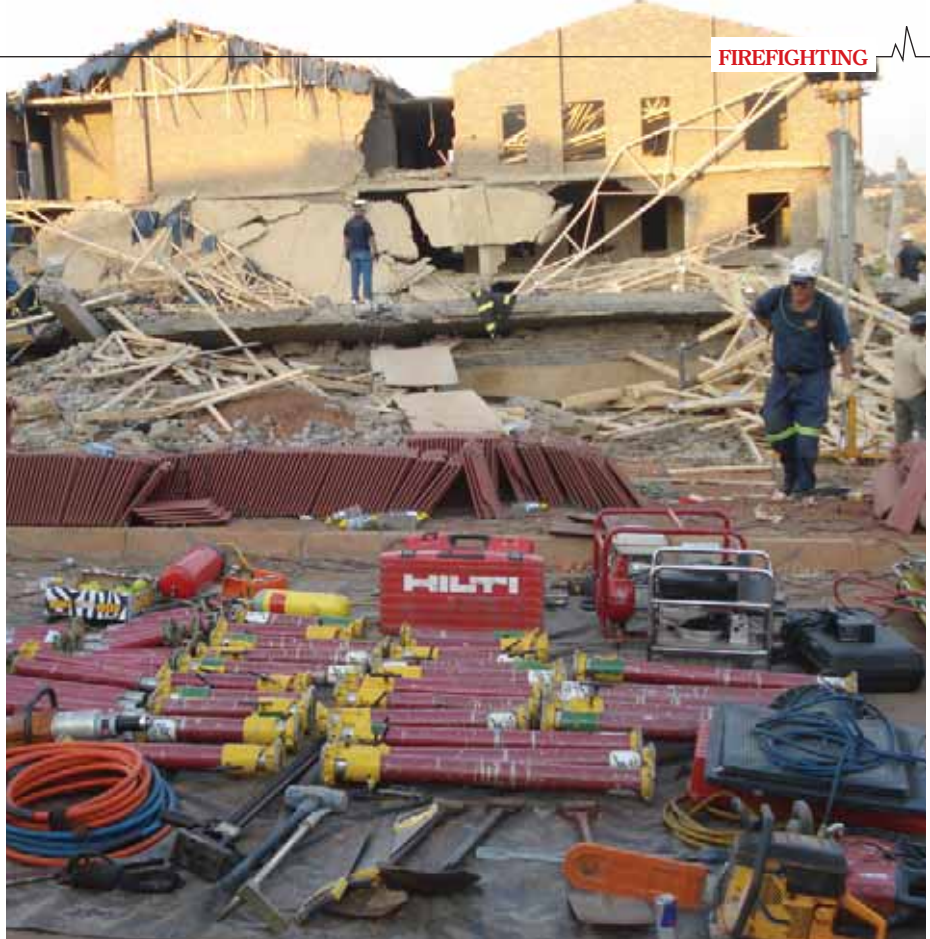
Initially, the operations were delayed by an hour when inspectors from the Department of Labour refused to allow the machine operators to work until they produced their operator's certificates

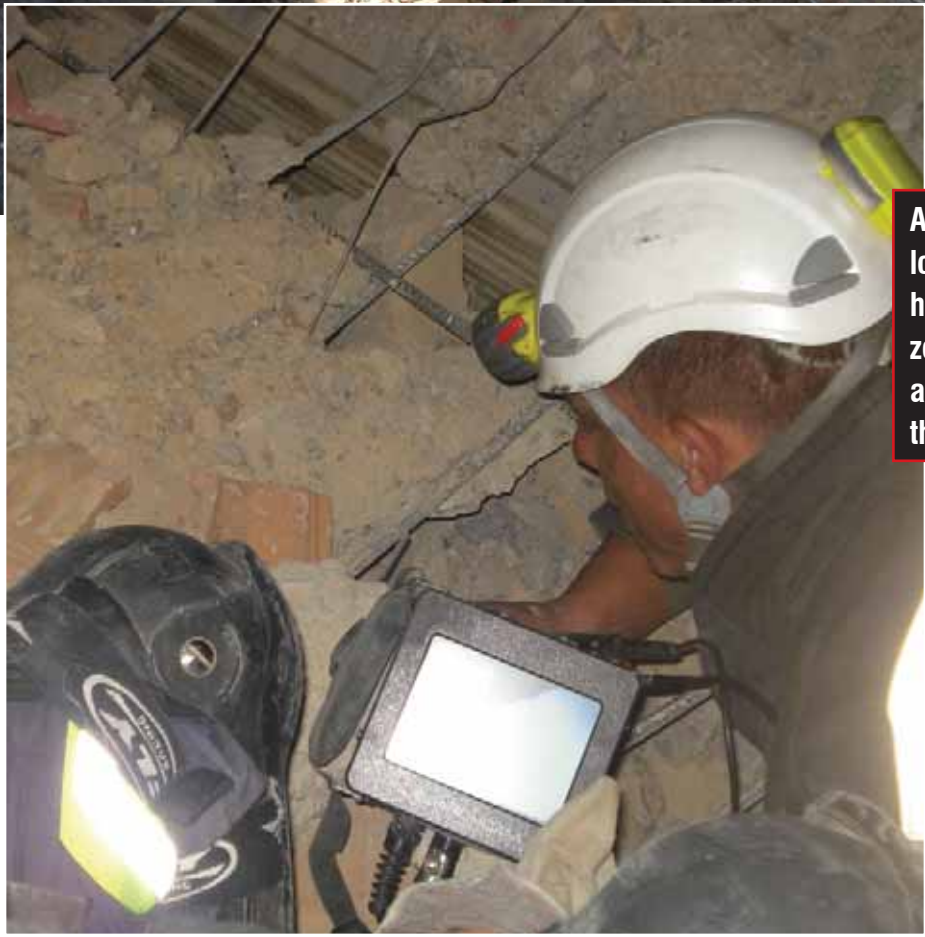
As the operations continued it began looking more likely that we would have to **move into the collapse zone** and it was decided to get the advice of an engineer to assist with the planning
